## **TAMU Project**

**Energy Consumption Data Quality Assurance/Quality  
Control Assessment Report for the  
Month of August 2016**

**Utility & Energy Services  
Division of Administration  
Texas A&M University**

**September 2016**

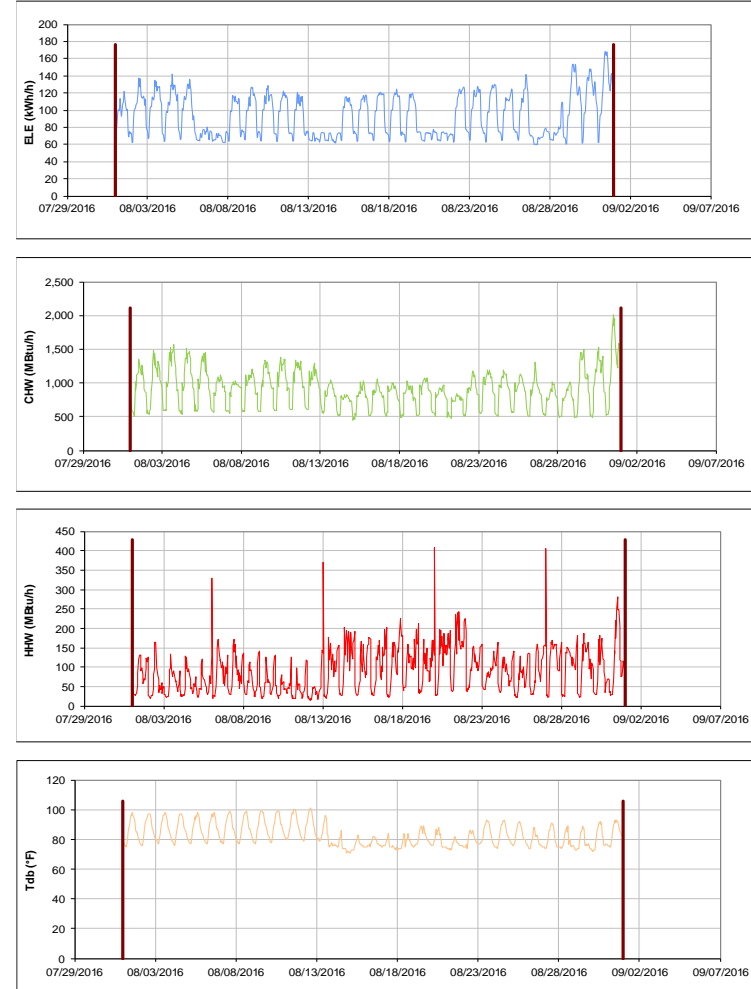
TAMU / BLDG #: 1540

Figure III-166 Hourly Whole Building Electricity, Chilled Water, and Hot Water Consumption for Physical Education Activity Program Building during the Month of August 2016 and the Corresponding Hourly Outdoor Dry Bulb Temperature for College Station, TX

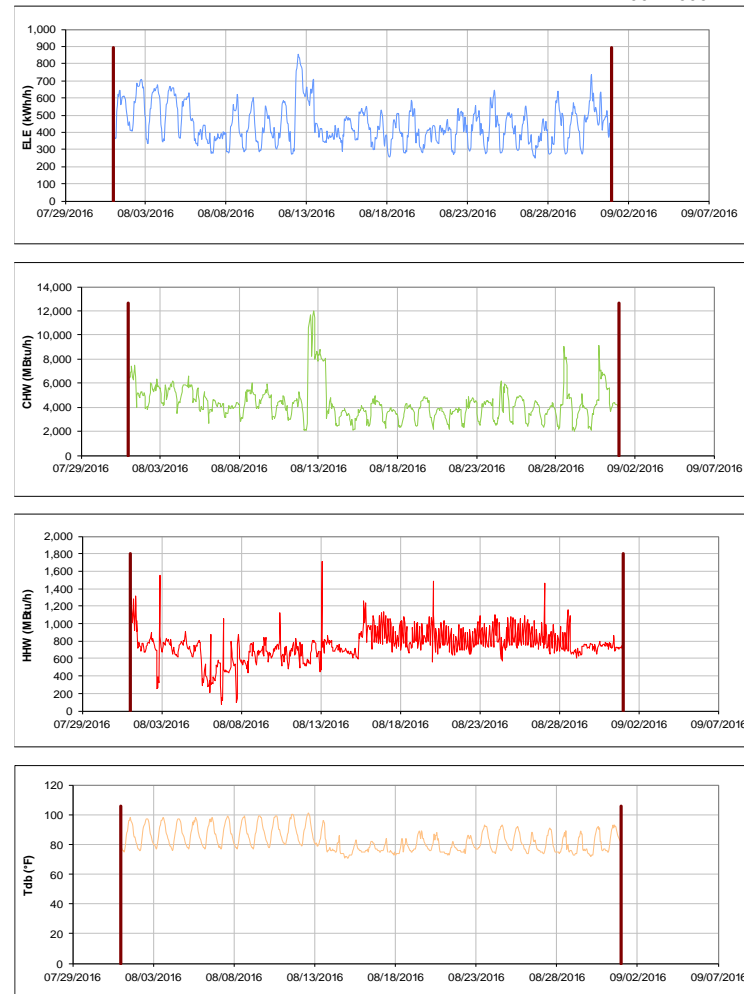
TAMU / BLDG #: 554-1558

Figure III-168 Hourly Whole Building Electricity, Chilled Water, and Hot Water Consumption for Reed Arena and Cox-McFerrin Center during the Month of August 2016 and the Corresponding Hourly Outdoor Dry Bulb Temperature for College Station, TX

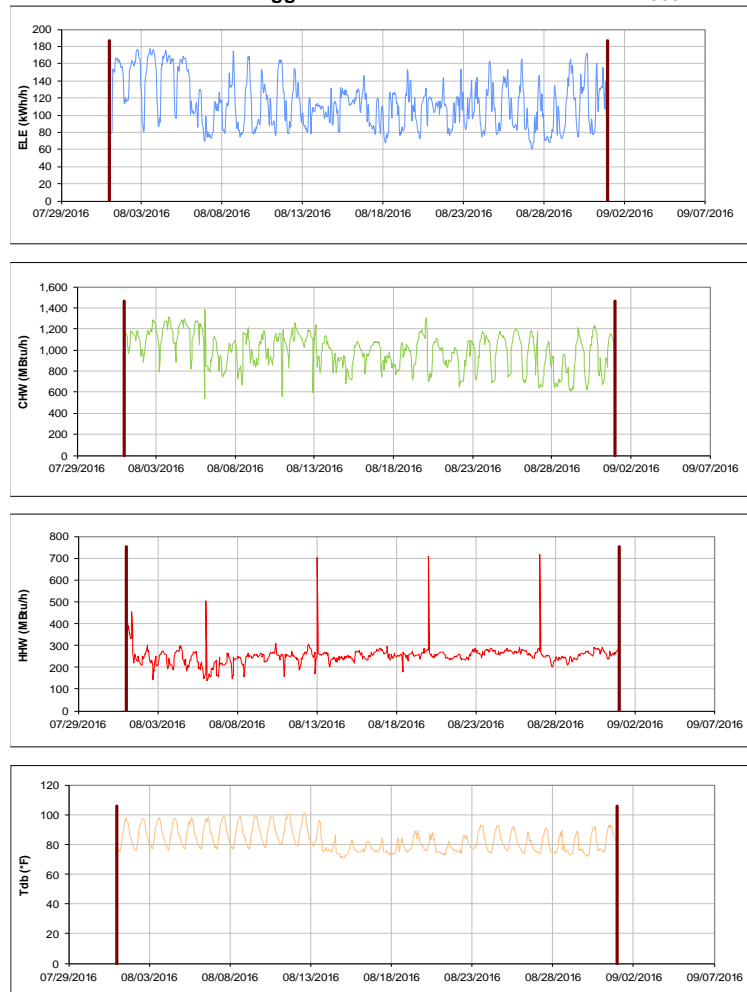
TAMU / BLDG #: 1558

Figure III-169 Hourly Whole Building Electricity, Chilled Water, and Hot Water Consumption for Cox-McFerrin Center for Aggie Basketball during the Month of August 2016 and the Corresponding Hourly Outdoor Dry Bulb Temperature for College Station, TX

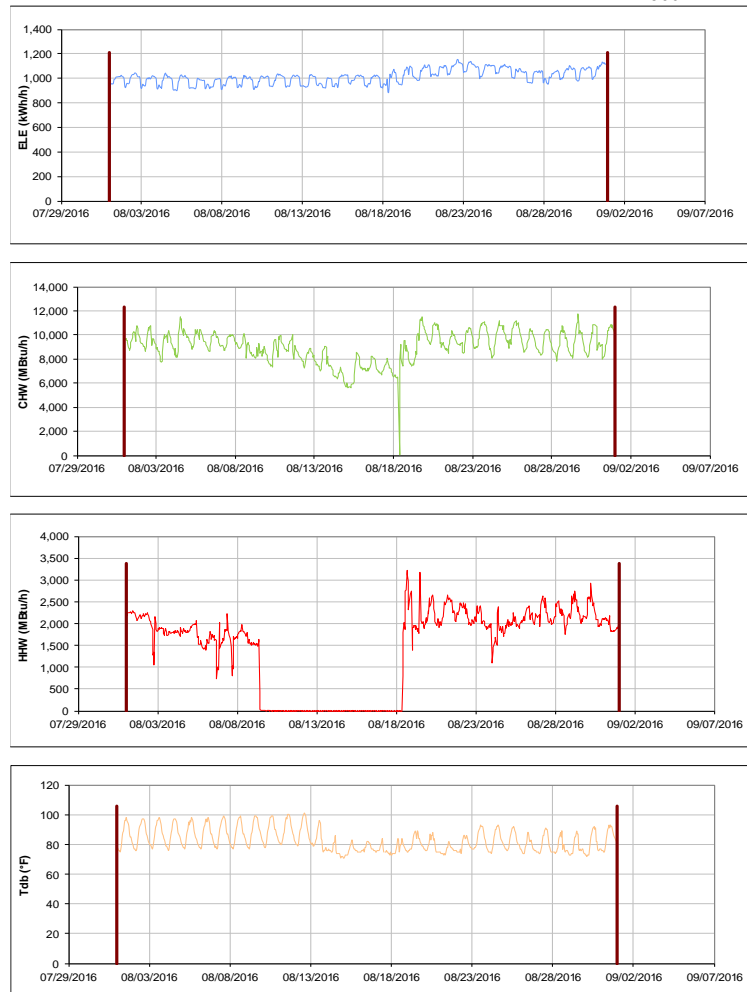
TAMU / BLDG #: 1560

Figure III-171 Hourly Whole Building Electricity, Chilled Water, and Hot Water Consumption for Student Recreation Center during the Month of August 2016 and the Corresponding Hourly Outdoor Dry Bulb Temperature for College Station, TX

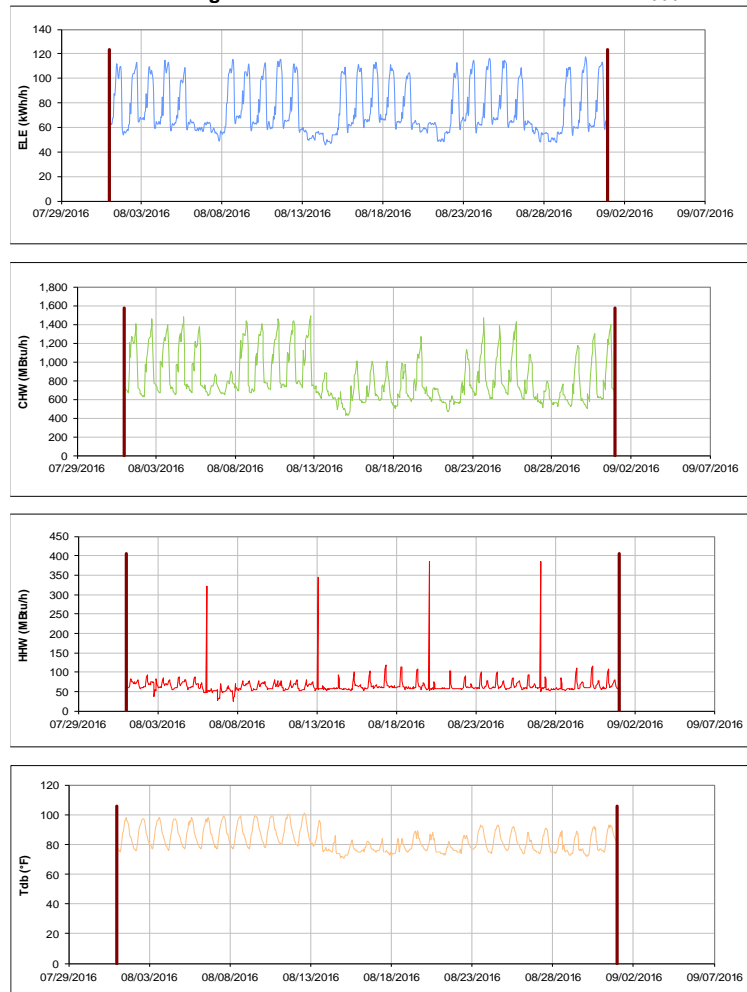
Figure III-175 Hourly Whole Building Electricity, Chilled Water, and Hot Water Consumption for Gilchrist TTI Building during the Month of August 2016 and the Corresponding Hourly Outdoor Dry Bulb Temperature for College Station, TX

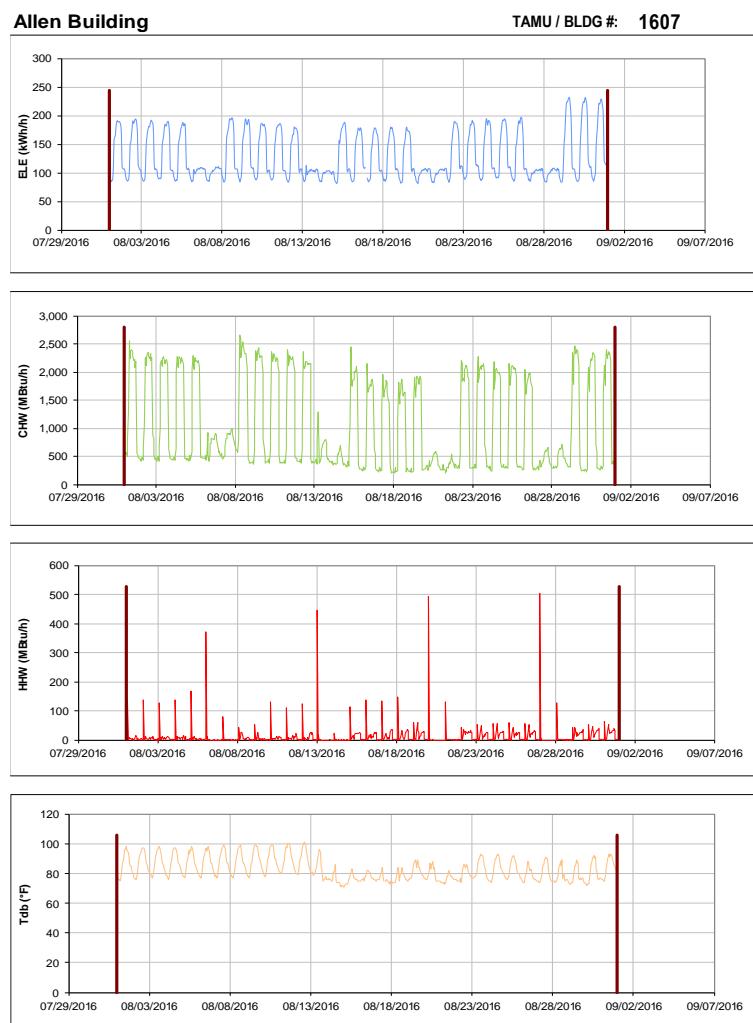
Figure III-179 Hourly Whole Building Electricity, Chilled Water, and Hot Water Consumption for Allen Building during the Month of August 2016 and the Corresponding Hourly Outdoor Dry Bulb Temperature for College Station, TX

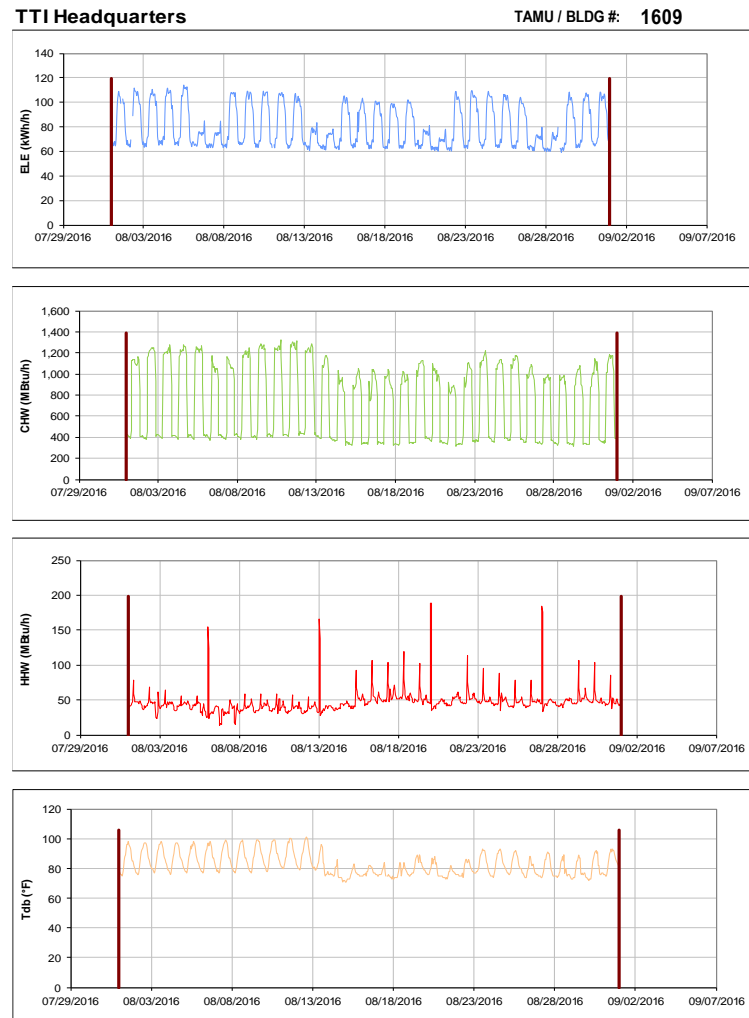
Figure III-181 Hourly Whole Building Electricity, Chilled Water, and Hot Water Consumption for TTI Headquarters during the Month of August 2016 and the Corresponding Hourly Outdoor Dry Bulb Temperature for College Station, TX

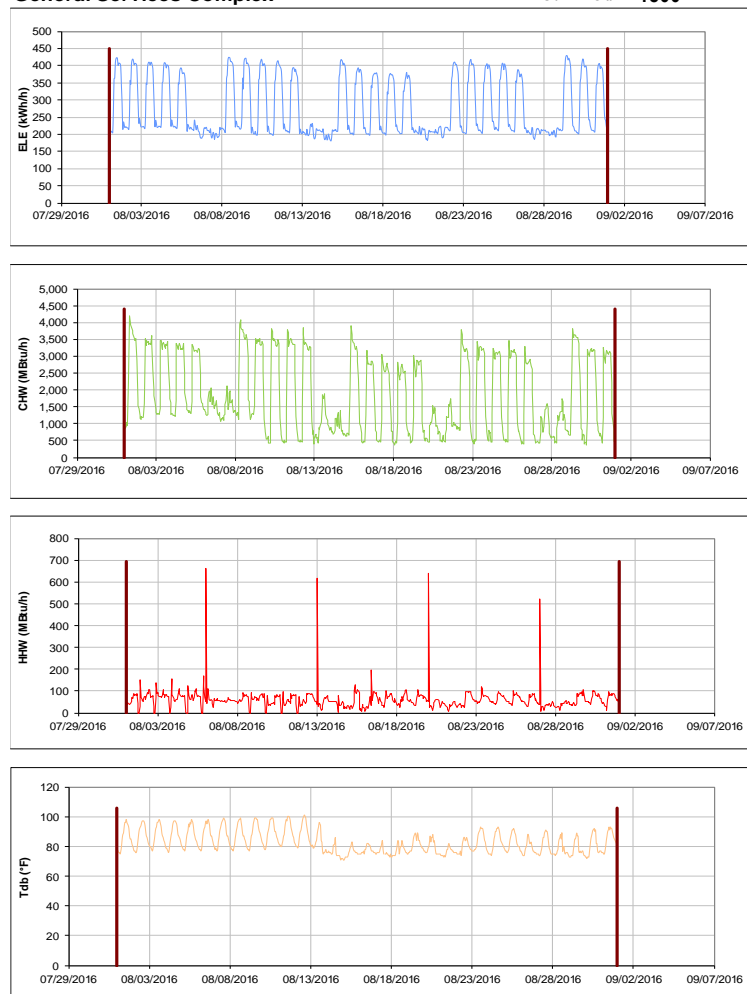
Figure III-183 Hourly Whole Building Electricity, Chilled Water, and Hot Water Consumption for General Services Complex during the Month of August 2016 and the Corresponding Hourly Outdoor Dry Bulb Temperature for College Station, TX

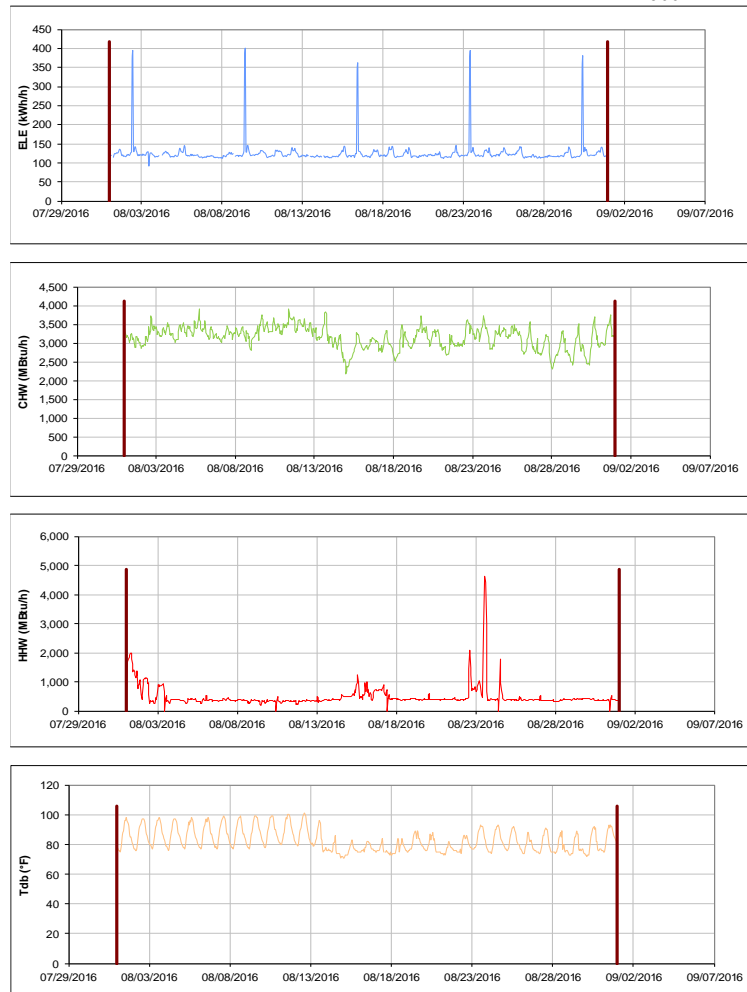
Figure III-187 Hourly Whole Building Electricity, Chilled Water, and Hot Water Consumption for Texas Institute for Genomic Medicine during the Month of August 2016 and the Corresponding Hourly Outdoor Dry Bulb Temperature for College Station, TX
